## *Frequently Asked Questions*

### *Palmyra Atoll and Kingman Reef Restoration/Shipwreck Removal*

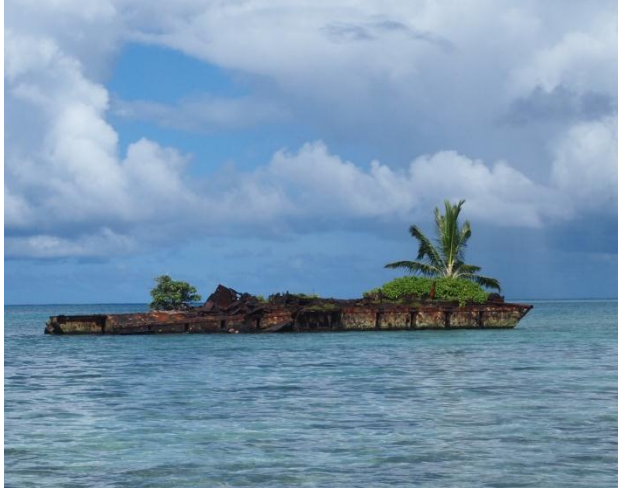
“Rust Island” October 2013

The pontoon barge, nicknamed "Rust Island" due to its highly degraded condition, was grounded near the western lagoon end of the entrance channel sometime between 1953 and 1957. It was believed to be a Defense Department transport barge made out of steel pontoon sections that linked together. Over the past several decades, Rust Island greatly deteriorated and sprouted vegetation, including even a small coconut tree. During removal operations it became evident that Rust Island was not just a pontoon barge with a mound of vegetation on it, but there were likely two small landing craft on top of the barge. By 2013, the landing craft were so degraded that only the engine components and propellers remained, surrounded by piles of metal scale.

The wreck site at Rust Island was shallow with approximately 4 to 5 feet of water at high tide. Because of the shallow depth, it was necessary to complete all removal operations during high tide. All vegetation was cleared from Rust Island, and the metal scale remains of the two landing craft were shoveled into buckets and totes. All debris was transported back to the 185-foot materials barge. Once Rust Island was cleared of all debris, the above-water portion of the pontoon sections were cut loose with an acetylene torch and loaded onto the transport scow. The intact below-water sections were lifted out of the water with a small crane affixed to the scow. Once the large metal portions were removed, the crew worked to gather metal scale remains of the decaying vessel on the ocean floor with shovels and buckets. Over half of the weight harvested from this wreck was removed by shoveling metal scale into five gallon buckets while snorkeling. The original estimated weight of Rust Island was 100,000 pounds, but with the additional landing craft remains, the final weight removed from the reef was over 277,800 pounds. On January 7, 2014 the site was declared clean.
